Deformation and damage to buildings caused by ground movements in mining areas (case study)

Lucyna FLORKOWSKA*¹, Izabela BRYT-NITARSKA¹, and Janusz KRUCZKOWSKI¹

¹Strata Mechanics Research Institute of Polish Academy of Sciences, Cracow, Poland

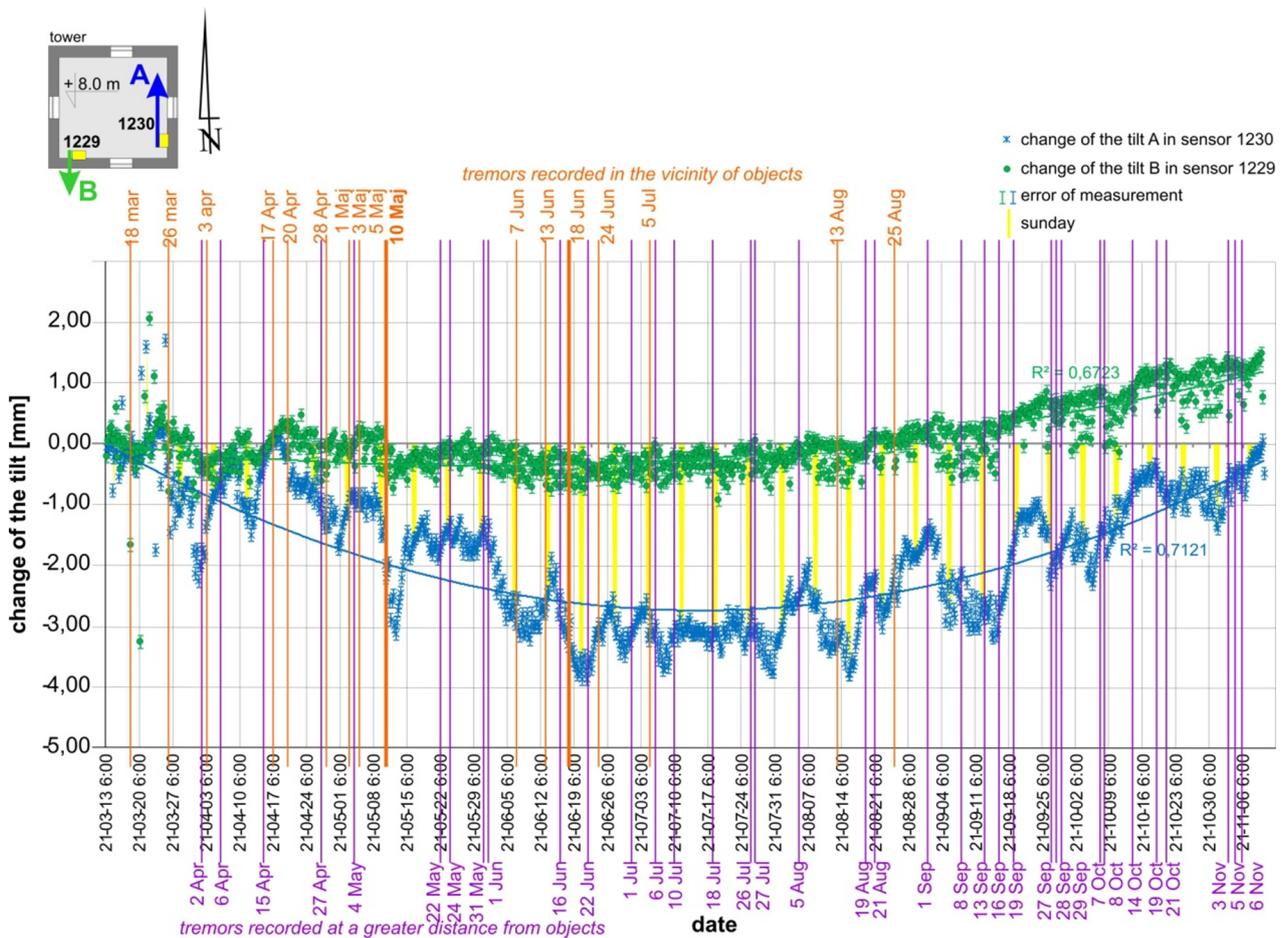
Figure 6. The graph of changes in the tilt of sensors in the N-S plane

The changes recorded by sensor 1229, mounted on the south wall, are small and remain close to zero most of the time. A slight southward tilting of the sensor can be detected from mid-September onwards. In contrast, the 1230 gauge, attached to the eastern wall of the tower, recorded a few millimetres increase in the northward tilt, which increased non-linearly from March to June, then remained constant for about two months, after which it began to decrease. The graph shown in Figure 7 shows the consistent pattern of tilts of both gauges in the E-W plane, from 13 March to 7 June. This is followed by a tilt difference between the sensors, which is then maintained at around 2 mm. The nature of the tilt pattern is similar for both gauges: they tilt westwards, with the tilt increasing non-linearly from March to mid-June, then stabilising before decreasing from mid-August.

The above pattern of tilts of the two sensors indicates that the main directions of the observed impacts do not coincide with the axes of the building plan, which causes twisting and turning of the cross-section of the tower. These directions changed during the observation period.

In both graphs, additional pronounced spikes appear on the leading line of the tilt change. They were explained by superimposing on the time axis the lines corresponding to the dates of the tremors recorded by the Upper Silesian Regional Seismological Network.

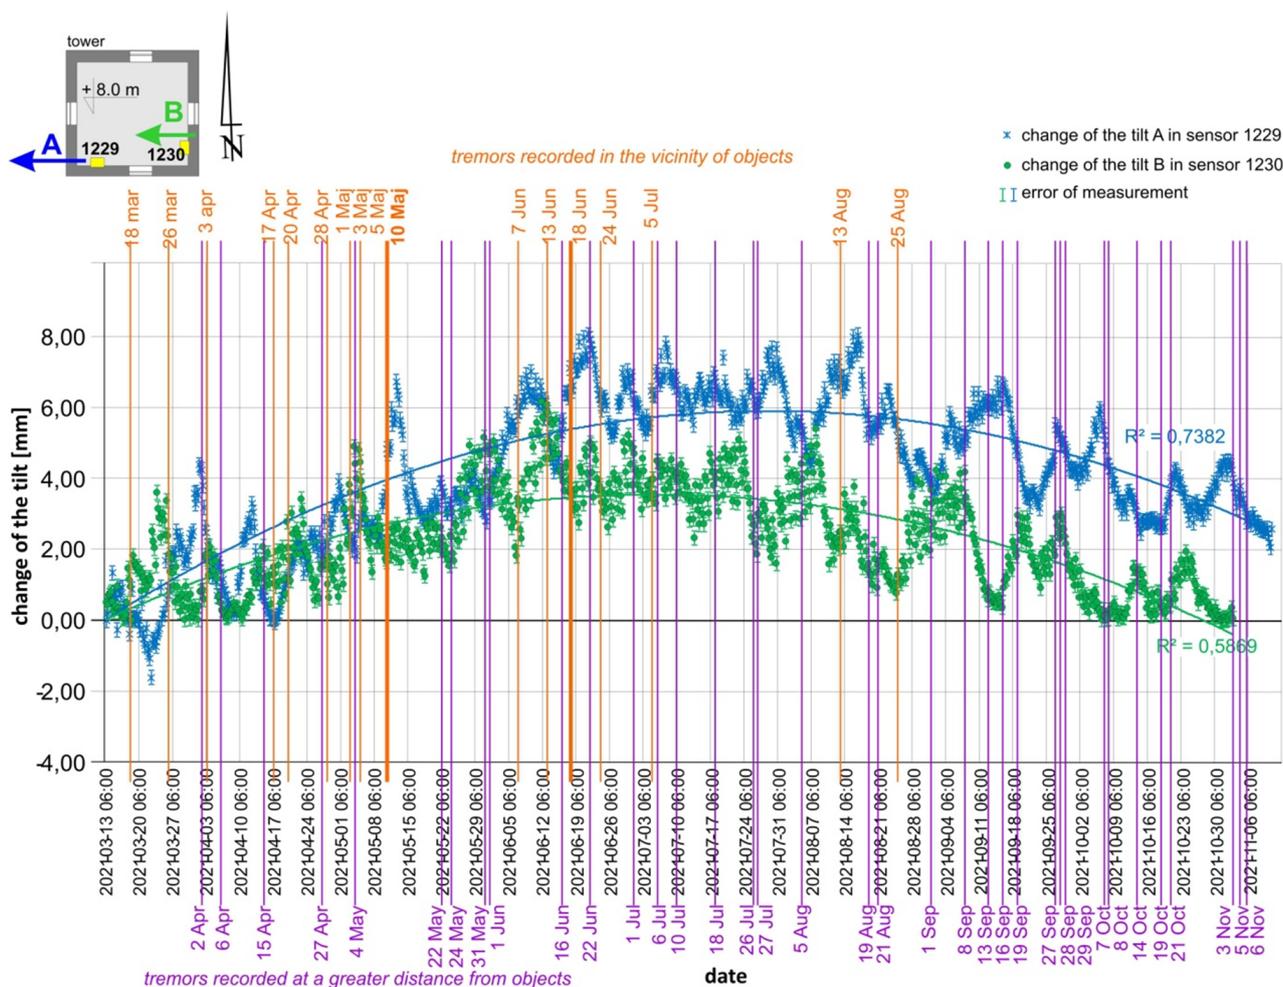
Figure 7. Graph of changes in the tilt of sensors in the E-W plane

In addition to the local deviations from the trend line mentioned above, there are noticeable anomalies occurring irregularly, which cannot be explained by software. These are spikes, reaching a few millimetres within 1-2 days. They were explained by superimposing on the time axis the lines corresponding to the dates of the tremors recorded by the Upper Silesian Regional Seismological Network. They are the structure's response to dynamic actions transmitted from the foundation. The most intense change of this nature was recorded by the instruments on 10 May 2021, corresponding to a tremor of 0.8066 mm/s² (Fig. 6 and 7).

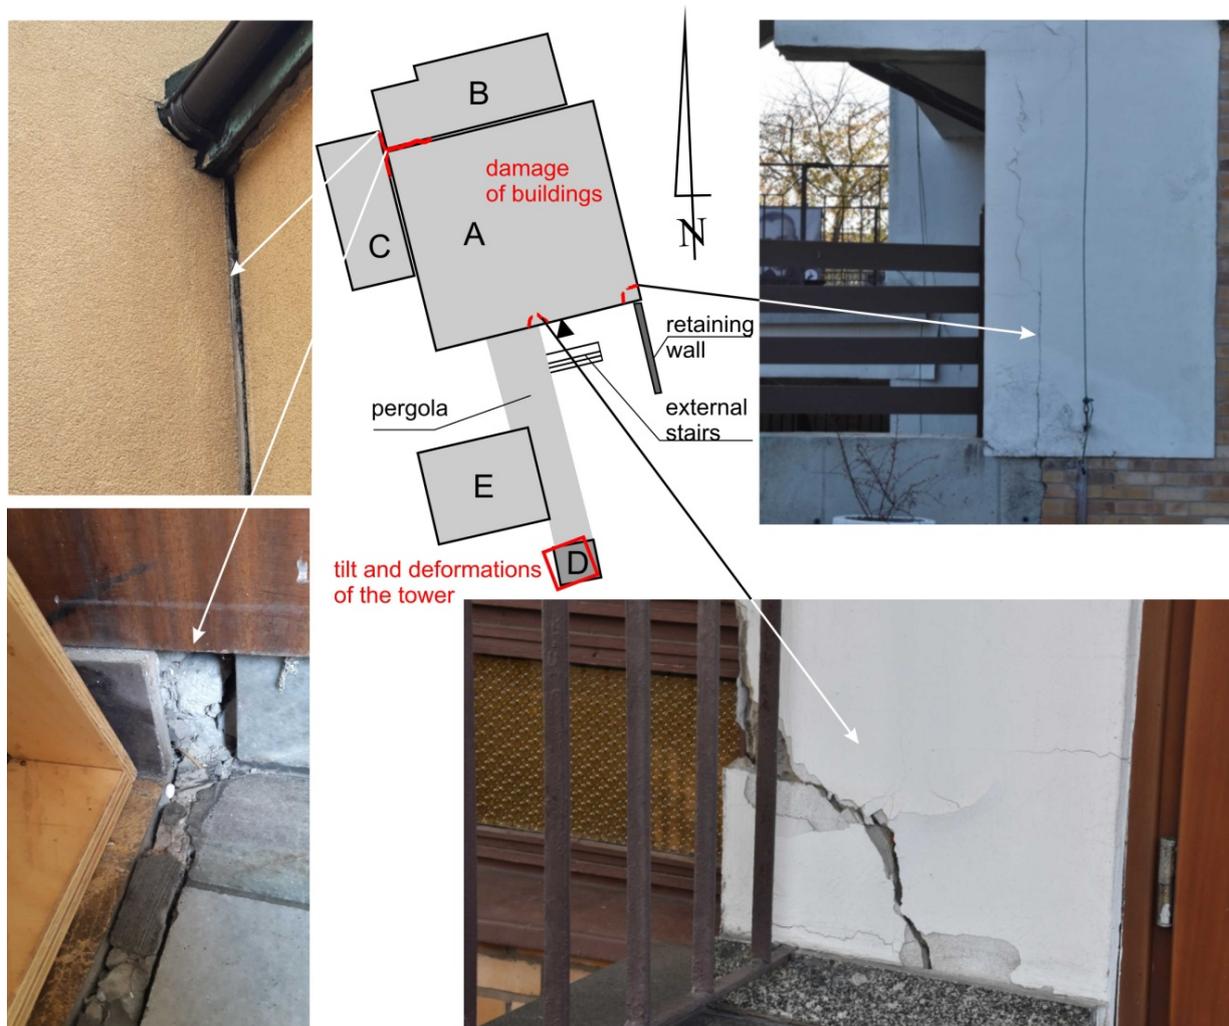
Based on periodic inspections of the structure of segments A, B, and C it was found that the building has a number of local damages, located mainly on the floor and walls, in places of expansion joints (Fig. 8). The nature and progression of the damage suggests that deformation is occurring in the subsoil, causing the structures to move northwards in line with the natural slope of the site. Despite the absence of any present mining works, damage propagation was noted

during the observation period. Analysis of the existing technical documentation has shown that no comprehensive geological prospecting was carried out either at the design stage of the structures (1980s) or during the design of the new retaining wall (2015). Five test holes, 2.5 m deep, were excavated prior to the design of the complex. After exposing about 30 cm of soil layer, small loamy sands, sandy dusts, and dusts in semi-solid and hard-plastic state were observed. These soils may be prone to plasticising under the influence of rainwater. This was considered to be non-hazardous due to the absence of groundwater up to a level of 2.5 m and the natural slope of the site.

Figure 8. Damage and deformation observed in buildings

For the construction of the new retaining wall, two geotechnical boreholes were drilled 3 m deep. In both boreholes, under the layers of non-construction mounds, hard-plastic and plastic dusts were found. In the light of the deformation and damage to the objects, the existing survey should be regarded as inadequate. In order to clarify the causes of the observed processes, an in-depth geological assessment should be carried out, based on test holes located around the building complex, with particular emphasis on the northern side. Cores should be taken from the holes for laboratory testing. It is advisable to consider the use of one or two boreholes for the installation of inclinometer pipes and monitoring of ground deformation. The results of the geological prospecting and inclinometric measurements will also be used as the basis for developing a protection concept for the site.

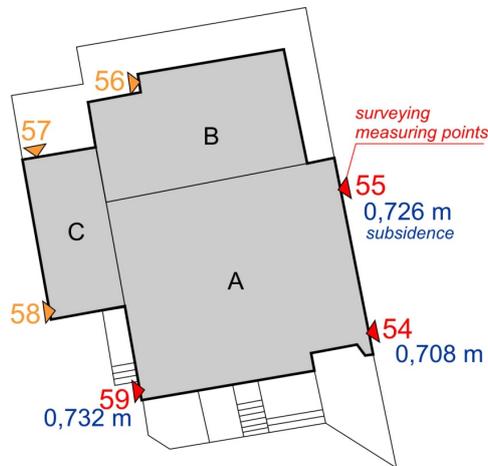
The obtained results of the tilt measurements were additionally correlated with the results of the surveying measurements carried out by the mine's surveyors. Survey measurements of the height of the benchmarks, installed on segments A, B, and C, had been carried out since 2003. Initially, the heights of six benchmarks were measured: 54, 55, 56, 57, 58 and 59, as of 2015, only benchmarks 54, 55 and 59 remained (Fig. 9). The subsidence determined on this basis over an 18-year period is: 70.8 cm for benchmark 54, 72.6 cm for benchmark 55 and 73.2 cm for benchmark 59. It can be concluded that along the contour of the church plan the subsidence is almost uniform; the difference in subsidence between the south-west corner (59) and the south-east corner (54) is 2.4 cm.

Figure 9. Subsidence of measurement points located on the church in the period 2003-2020

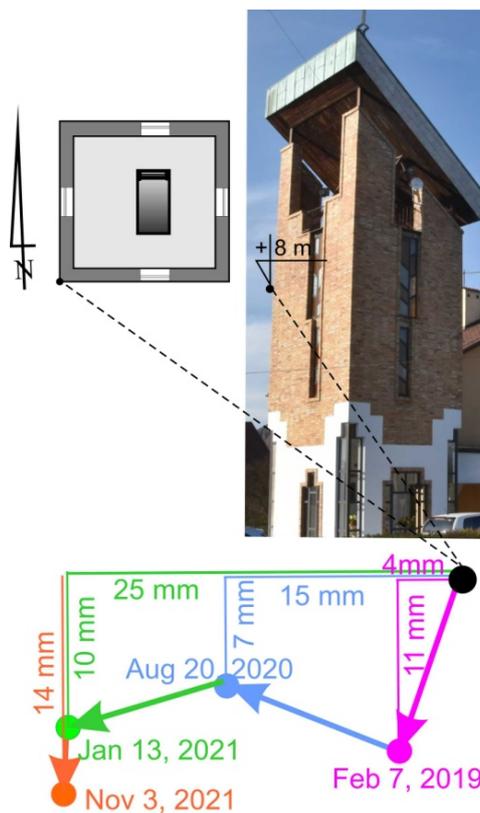
Starting in 2019, surveys were made of the tilt of the south-west edge of the tower. The horizontal displacement of a point, located 8 m above ground level, was measured. The results obtained in the following measurement sessions, from February 2019 to November 2021, are shown in Fig. 10. From the data obtained, it was found that the magnitude of the tower tilt (at 8 m height) changed over 22 months from 11.7 mm to 29.5 mm, which (assuming linearity) corresponds to a change from 1.5 to 3.7 mm/m. The difference in tilt between January and November 2021 (which

roughly corresponds to the period of the measurements in question) is: 1 mm for the N-S component, 4 mm for the E-W component.

Figure 10. Results of surveying measurements of the tower tilt, made from Feb. 7, 2019 to Nov. 3, 2021
