Building modernization located in the conservation protection zone in the aspect of technical conditions

Maciej NIEDOSTATKIEWICZ^{*1}

Abstract

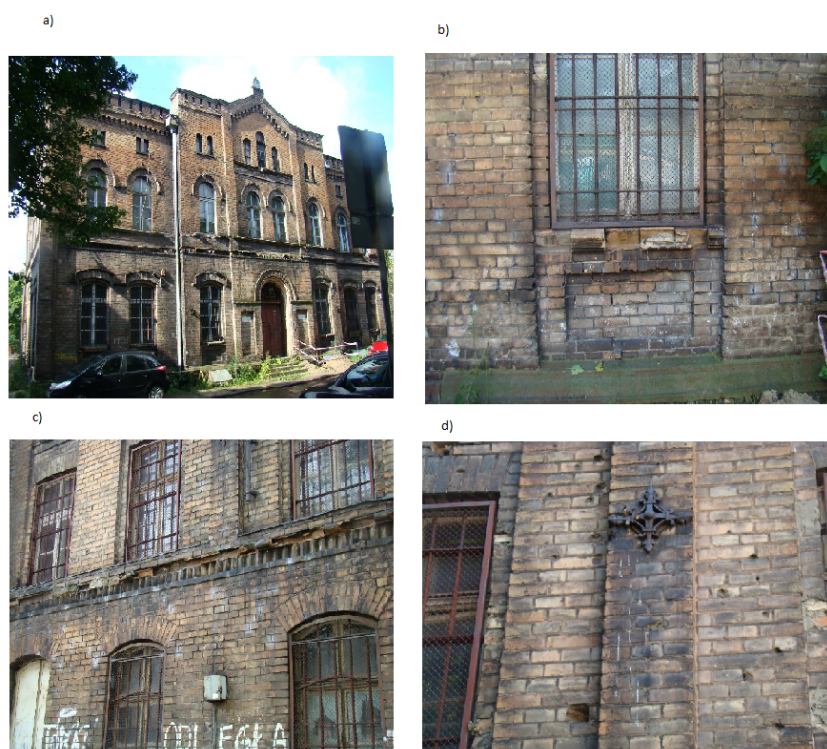
The general view of the building from the north-eastern façade is shown in Figure 3a. On the north-west façade, traces of mechanical damage to the wall were visible, moreover, extensive damage was visible in the form of scratches in the

sill zones (Fig. 3b). In addition, scratches on the window vaults were visible on the façade (Figure 3c). Decorative thrust washers of front bolts were visible on the elevation plane (Fig. 3d).

Figure 3. Building planned for modernization - elevations: north-east: a) view, north-west: damage to: b) the sill zone, c) brick basement window lintels (arches), d) front anchoring retaining plate

The scratches visible on the façade occurred in the sash strips and in the area of lintels - these are places where the stiffness of the wall was changed and the occurrence of scratches in these places, especially diagonal and close to diagonal, was explainable. The vertical and slightly sloping cracks visible on the elevations, locally turning into cracks, were damage whose morphology indicates that they are the result of thermal deformation of the external walls.

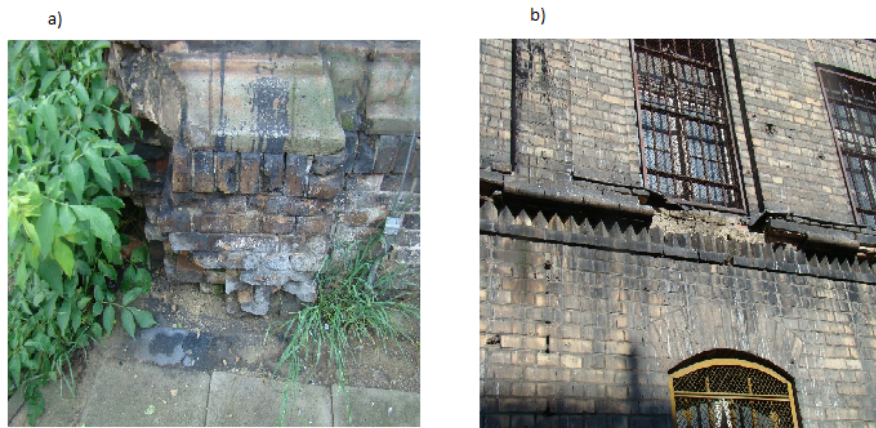
The corner of the building at the junction of the south-west and south-east façades was cracked, and the morphology of its scratches (scratches and diagonal cracks) indicated that it was gradually subsiding (Fig. 4a).

Very large losses of ceramic decorative elements were visible on the façade surface (Fig. 4b).

Figure 4. Building planned for modernization - south-eastern elevation: damage to the brick wall: a) in the level of the plinth, b) in the level of the above-ground part

The oblique scratches, in particular the oblique scratching in the corner area of the south-west and south-east façades, testified to the local occurrence of uneven subsidence, probably caused by local softening of the subsoil resulting from changes in the groundwater level.

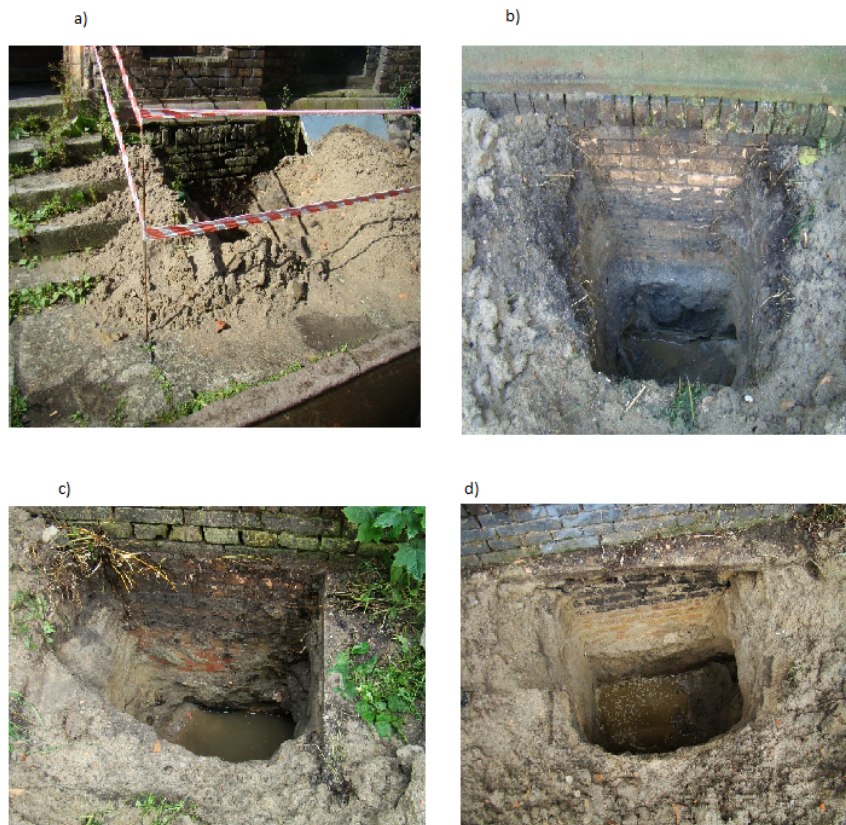
Figure 5. Building planned for modernization - outcrops from the side of the elevation: a) north-east, b) north-west, c) south-west, d) south-east

The groundwater level was not visible in the F1 outcrop along the north-eastern (front) elevation (Fig. 5a). The top level of the concrete footings made of rubble concrete was 60 cm below the ground level. In the F2 outcrop along the north-west elevation, groundwater was visible at the level of 65 cm below the level of the top of the continuous

footings (Fig. 5b). The top of the footings was 85 cm below the area around the building.

In the F3 outcrop, also made along the north-west elevation, groundwater was visible at the level of 60 cm below the level of the top of the footings (Fig. 5c). The top of the footings was 90 cm below the area around the building.

In the F4 opencast along the south-eastern elevation, groundwater was visible, similarly to the F2 and F3 opencasts, at the level of 60 cm below the level of the top of the continuous footings (Fig. 5d). The top of the footings was 95 cm below the area around the building.

At the level of the top of the footings, there was no anti-moisture insulation to prevent capillary rising of moisture by the ceramic wall, and the footing itself (foundation plinth), as well as the part of the ceramic wall recessed into the ground, were not protected against the negative effects of moisture (water). On the basis of the excavations, it was found that the groundwater level was approximately at the foundation level, which resulted in the building structure being exposed to deformation due to the changing (fluctuating) stiffness of the ground caused by its periodic irrigation or drying. Thus, the probability of subsequent damage to structural elements, including external walls, was significantly increased. It should be noted that in the event of a targeted change in the use of the building, the unit ground pressure on the ground would increase and thus the probability of faster and increased subsidence of the building structure as a whole would increase. At the stage of assessing the technical condition of the building in terms of its potential modernization, it was not possible to clearly determine what will be the increase in loads and pressures on the ground after the target change in the way of use. According to the recommendations commonly used in engineering practice, if this increase is more than 20%, which is highly probable, the existing footings will be eligible for reinforcement.

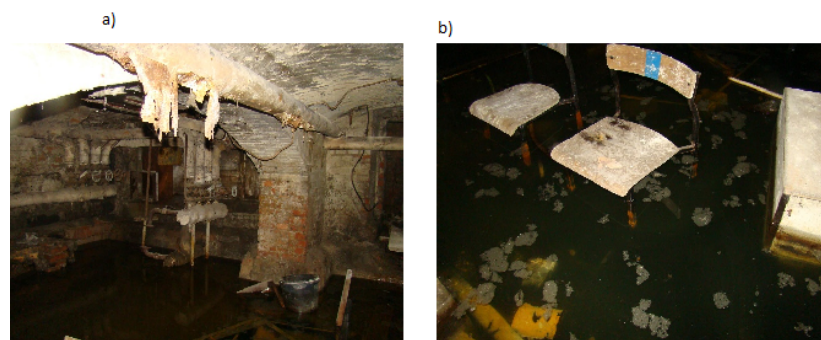
Figure 6. Building planned for modernization - flooded cellars: a) view, b) close-up

In the basement level, the consequences of the utilization of the building with inefficient waterproofing of parts of the walls sunk into the ground were visible. In practice, the entire cellars were flooded with water (Fig. 6a).

Section vaults constituting the vaulting of the basement storey were loosened, loose bricks falling out of keystones and scratches of joints on the entire palate of the vaults were visible. In most of the rooms in the basement level there was water, the basements were flooded to a height of 50 cm (Fig. 6b).

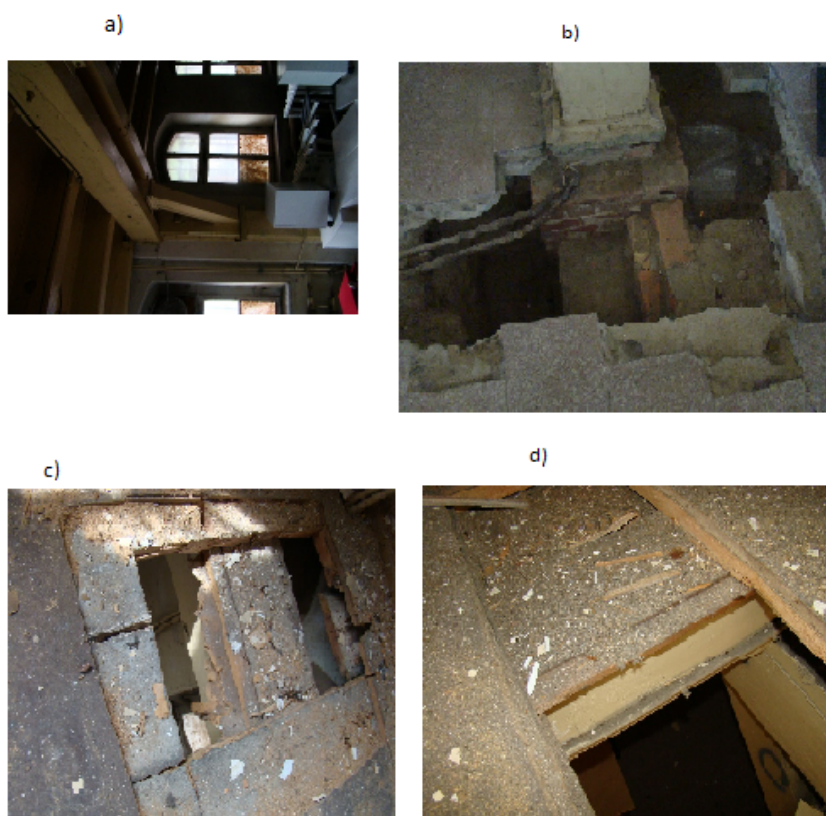
Figure 7. Building planned for modernization ceiling above the ground floor: a) fragment of the wooden frame, b) foundation of the column, c), d) structure of the stop

Wooden posts and wooden bolts on the ground floor level showed numerous scratches, delamination and cracks (Fig. 7a). The dimensions of the wooden poles in the cross-section were 32x32 cm, the transoms were made as two-branch transoms from beams 2x15x31 cm. The foundation of the columns on a brick foundation (Figure 7b) was to ensure the vertical non-deformability of the wooden structure. Stiffening of the structure of wooden frames was provided by swords measuring 15x35 cm. Wooden ceiling beams with dimensions of 15.5x28 cm were spaced from 65 to 80 cm. The ceiling above the ground floor was made of wooden naked. In the outcrops, it was found that the floor beams were made of 3.8 cm thick boards (Fig. 7c and Fig. 7d). On a part of the ceiling, additionally, during the period of operation, a hard-type fibreboard with a thickness of 0.5 cm was impaled on the boards.

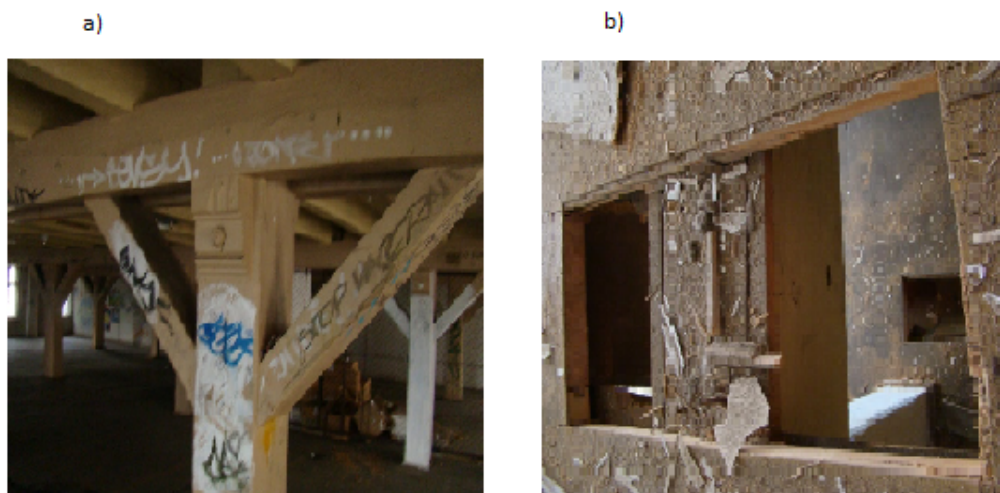
Figure 8. Building planned for modernization ceiling above the first floor: a) fragment of the wooden frame, b) structure of the ceiling

Wooden posts and wooden bolts on the first floor level, similarly to the ceiling above the ground floor, showed numerous scratches and cracks (Fig. 8a). The dimensions of the wooden poles in the cross-section were 32x32 cm, the

transoms were made as two-branch transoms from beams 2x15x31 cm. Stiffening of the structure of wooden frames was provided by swords measuring 25x35 cm. Wooden ceiling beams with dimensions of 15.5x28 cm were spaced from 80 cm to 90 cm. The ceiling above the ground floor was made of wooden naked, as in the case of the ceiling above the ground floor. It was found in the open-pit mines that the floor beams were made of 3.8 cm thick planks covered with 0.5 cm thick hard-type fibreboard (Fig. 8b).

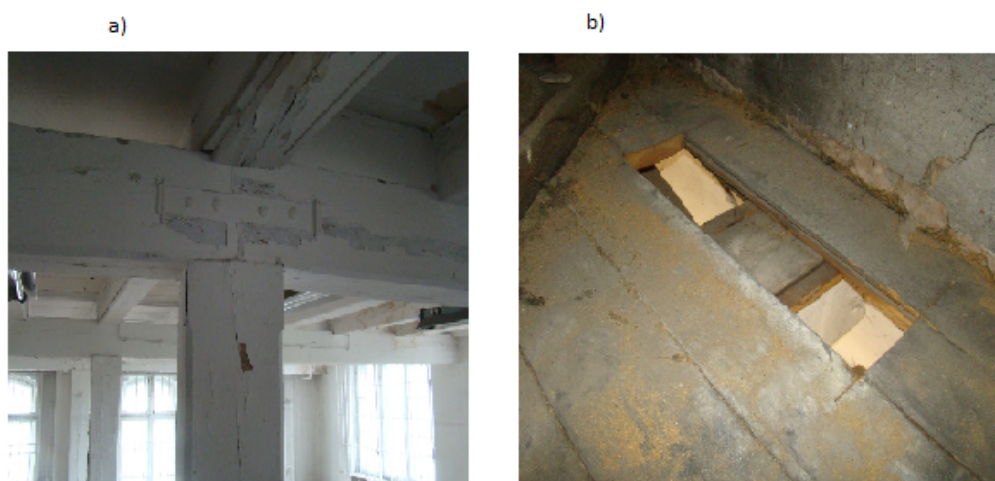
Figure 9. Building planned for modernization - ceiling above the second floor: a) a fragment of a wooden frame, b) a structure of the ceiling

Wooden posts and wooden bolts on the second floor, similarly to the ceiling above the ground floor, showed numerous scratches and cracks (Fig. 9a). In some of the rooms on the second floor, leaks were visible due to leakage of the roof covering. The dimensions of the wooden poles in the cross-section were 32x32 cm, the transoms were made as single-branch transoms from 25x30 cm beams. The structure of the ceiling above the second floor does not have a stiffening in the form of swords next to wooden poles. The direction of constructing the transverse frames horizontally

above the 2nd floor (perpendicular to the front façade) was perpendicular to the direction of their construction horizontally above the 1st floor and above the ground floor (parallel to the front façade). Wooden ceiling beams with dimensions of 15.5x28 cm were spaced from 85 cm to 90 cm. The ceiling above the ground floor was made as wooden naked, as in the case of the ceiling above the ground floor and above the first floor (Fig. 9b). In the outcrops, it was found that the floor beams were made of 3.8 cm thick planks with a 0.5 cm thick hard-type fibreboard covering.

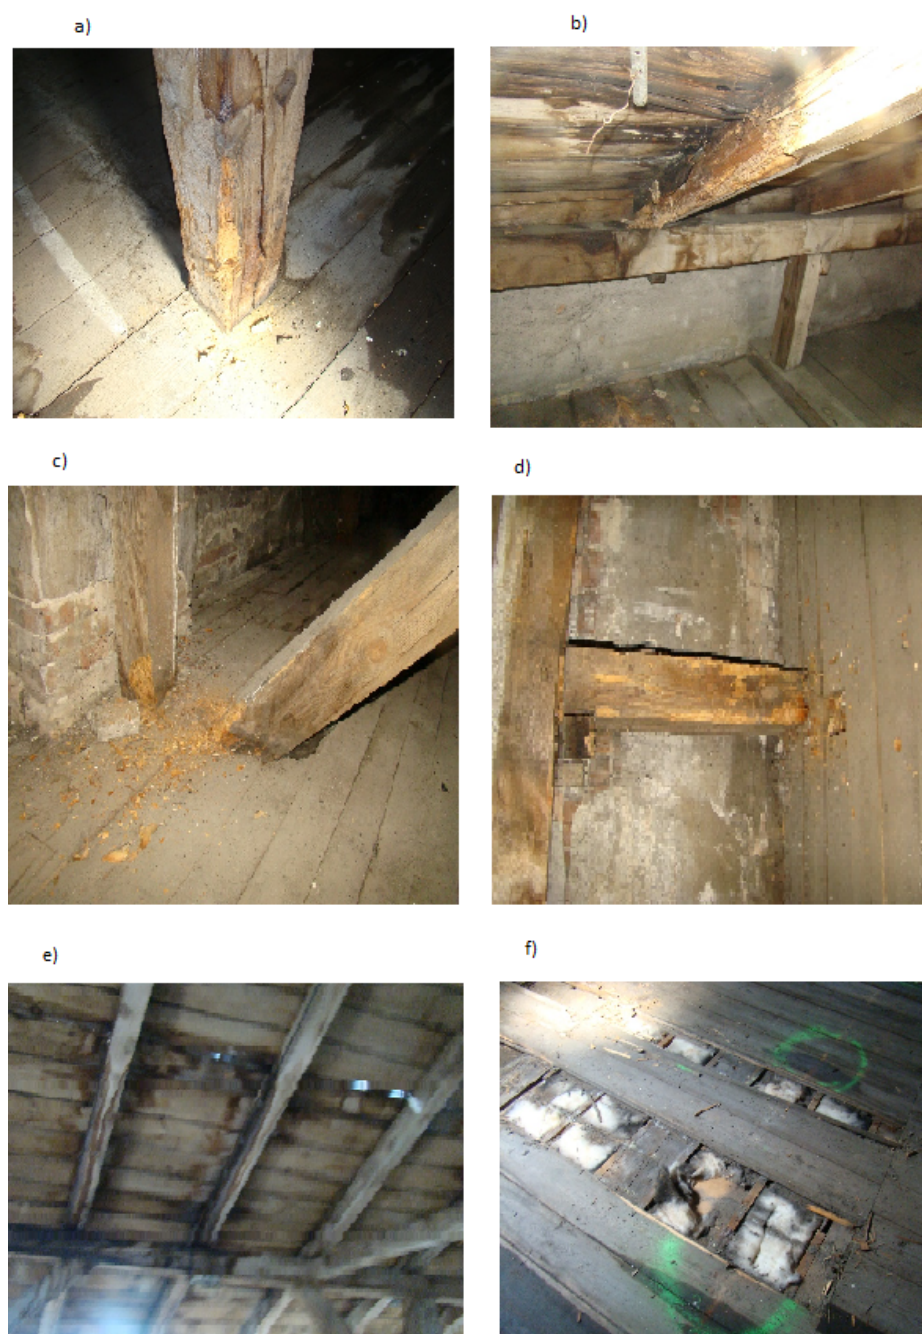
Figure 10. Building planned for modernization - attic: damage to the wooden roof truss in terms of: a) post foundation, b), c) rafter backrest, d) wall board support, e) roof formwork, and f) ceiling structure above the second floor

In the attic level, the elements of the wooden roof truss had extensive damage. Some of the wooden posts showed, along their entire height, traces of larvae and insect feeding (Fig. 10a). In most cases, the roof rafters were damp as a result of leaks in the roofing material. Long-term dampness led in some cases to significant corrosion losses, reaching up to 80% of the cross-sectional area (Fig. 10b). Corrosion damage also occurred at the anchoring point of the diagonal strut in the floor beams (Fig. 10c). The posts supporting the wall plate were in some cases so damaged by corrosion that they hung in the air (Fig. 10d). The formwork of the roof was damp as a result of leakage of the roof covering (Fig. 10e). Moistening of the floorboards was also identified (Fig. 10f).

The direct cause of the dampness of wooden elements were leaks from the roof slope occurring in the past period, with a high probability assessing the extent of damage that has been maintained for many years.

In the case of a fragment of the attic from the south-west elevation, the development of biological corrosion led to almost complete degradation of the rafters.

- wooden roof truss - disassembly of the existing roof truss and its reconstruction (boarding and load-bearing structure).
 - roofing - disassembly of the existing and reconstruction of the roofing,

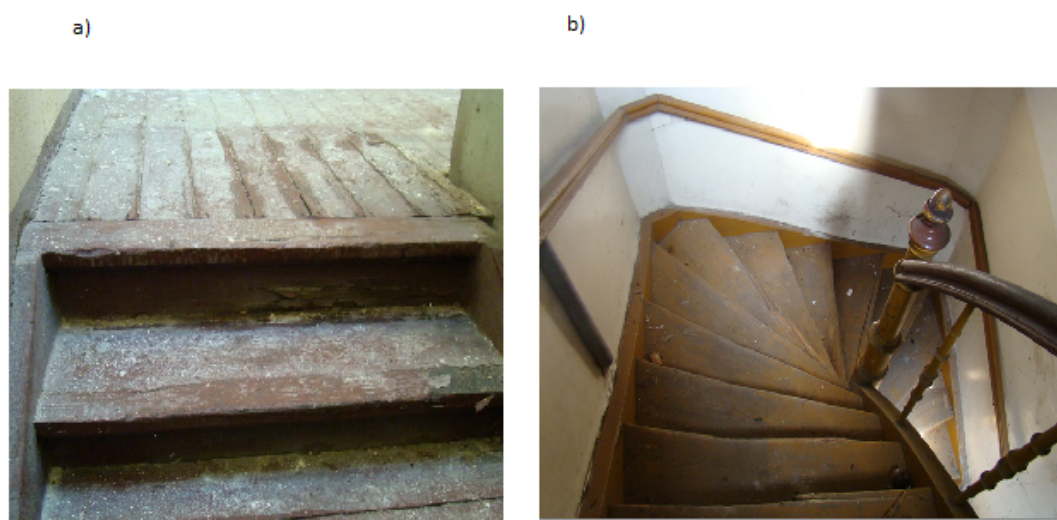
Figure 11. Building planned for modernization - damage to the runs of staircases: a) main and b) side

The main staircase had landings and running boards made of wooden elements. The steps were worn, the footrests and legrests were mechanically damaged (Fig. 11a), with extensive traces of larvae and insect feeding. The side

staircase was in a very similar technical condition, the communication of which was provided by the return operation stairs (Fig. 11b).

- staircases - reconstruction of staircases with particular emphasis on the need to adjust the width of escape routes and fire protection of structural elements.

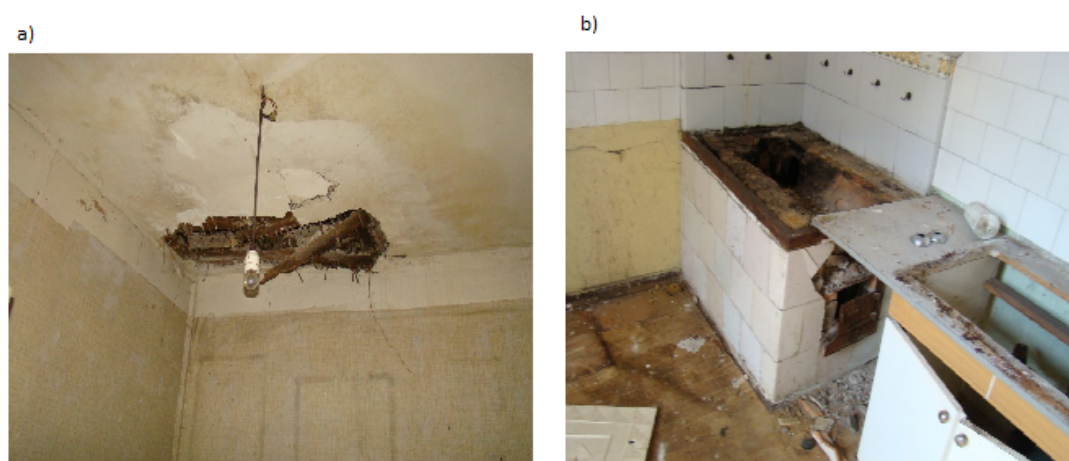
Figure 12. Building planned for modernization – lokale mieszkalne: a) broken ceiling above the ground floor, b) depreciation of equipment

The residential premises in the area of the building were out of service, there were visible traces of extensive water stains and mechanical damage to the finishing layers (Fig. 12). The walls and ceilings of the plastering were chafed and locally damp. There were pipe installations in the rooms, and the cable systems in most of the rooms of the residential premises were also dismantled.
