# SAFETY ENGINEERING OF ANTHROPOGENIC OBJECTS

## AUTHOR'S METHOD OF CONTINUUM STATES ON THE EXAMPLE OF IMPERFECTION IN THE CONSTRUCTION OF A LARGE-PANEL BUILDING

Piotr BIERANOWSKI

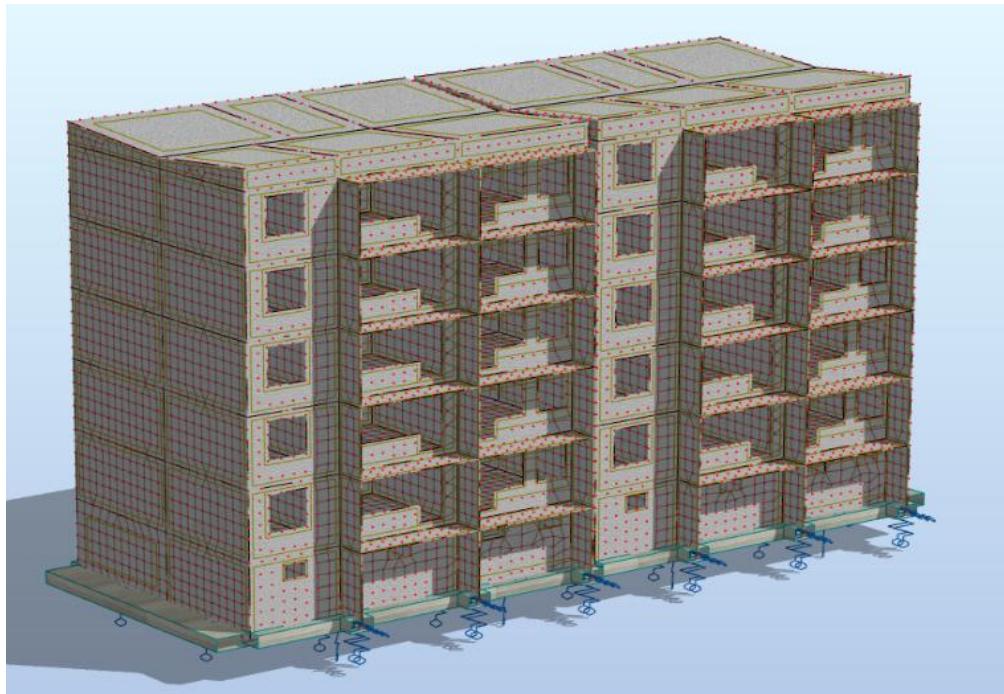
**Fig. 1.** Residential building of the Wk-70 large-panel system (F.D. Iława) - 5-storey, southern facade - FEM 3D model of the building structure on an elastic foundation (Bieranowski P. 2019)

1. In order to present the secondary distribution of normal stress  $\sigma_x$  [MPa] caused by cracking the reinforced concrete composite, an original FEM coating model of the Wk-70 System multi-panel building structure was built. The theoretical shell model, Fig. 1, not only takes

into account the rigid-spatial global operation of the structure, but also represents cooperation with the elastic half-space of the soil medium [8,9,10,11,12,13]. The last one allows to monitor displacements and, as a result, to determine the place of possible scratch formation - in the zone (s) of the most interactively accumulated displacements caused by subsidence. The housing estate on which the building is erected is illustrated in fig. 2.

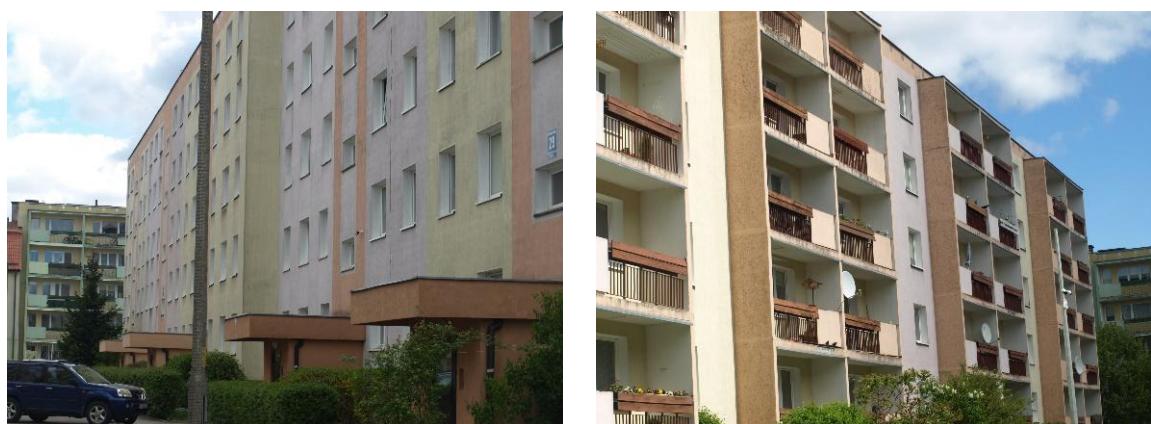
**Fig. 2.** Residential building of the Wk-70 large-panel system - V floor, elevation view: a) north, b) south on the left (Bieranowski P. 2018)

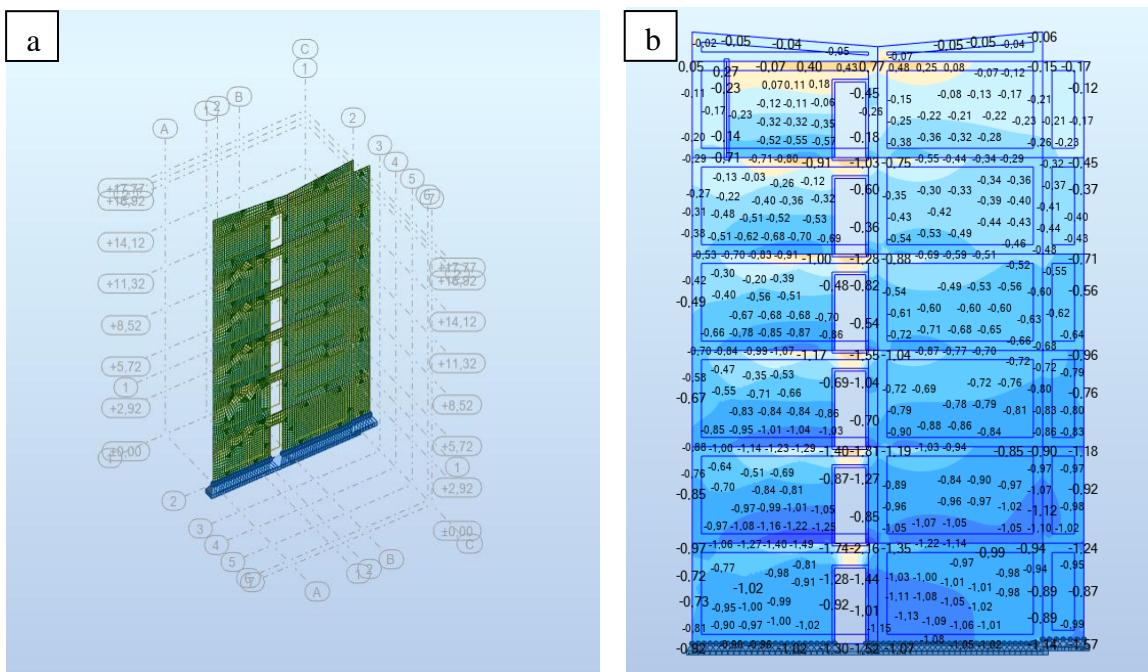
**Fig. 3.** 3D view of the FEM model of the structure of a separate diaphragm, integrally connected to the vertical communication structure a) triple meshing using Delaunay's complex method, b) FEM map of normal stress  
(Bieranowski P. 2019)

In the issue of FEM computer modeling, discretization plays a very important role, which has a direct impact on the results obtained. In the described model, triple meshing using the Delaunay composite method, with the mesh side dimension  $a = 0.1$  m [10,11,12,13].

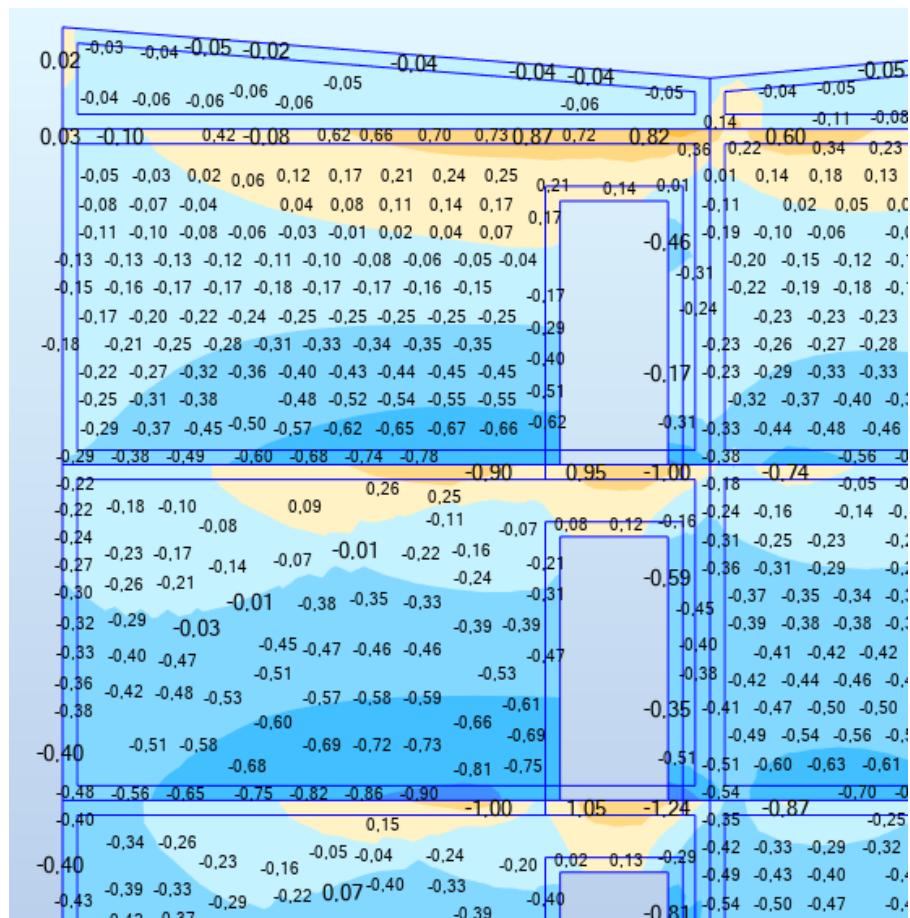
**Fig. 4.** A fragment of the MES1 comparative model - analyzed large panel panel - attic wall - (Bieranowski P. 2019)

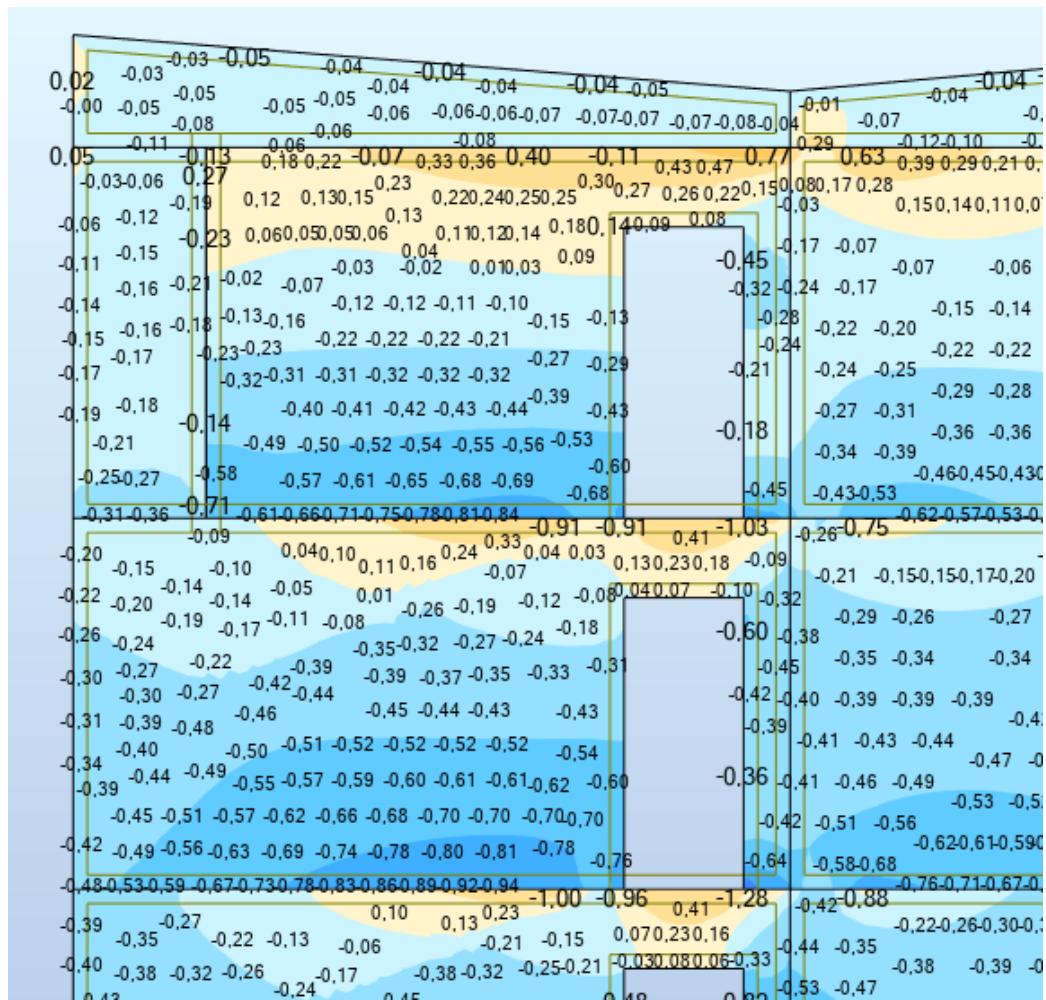
**Fig. 5.** A fragment of the MES2 model - a through crack with an opening of  $w_k = 3 \text{ mm}$  - through the entire height of the attic wall - (Bieranowski P. 2019)

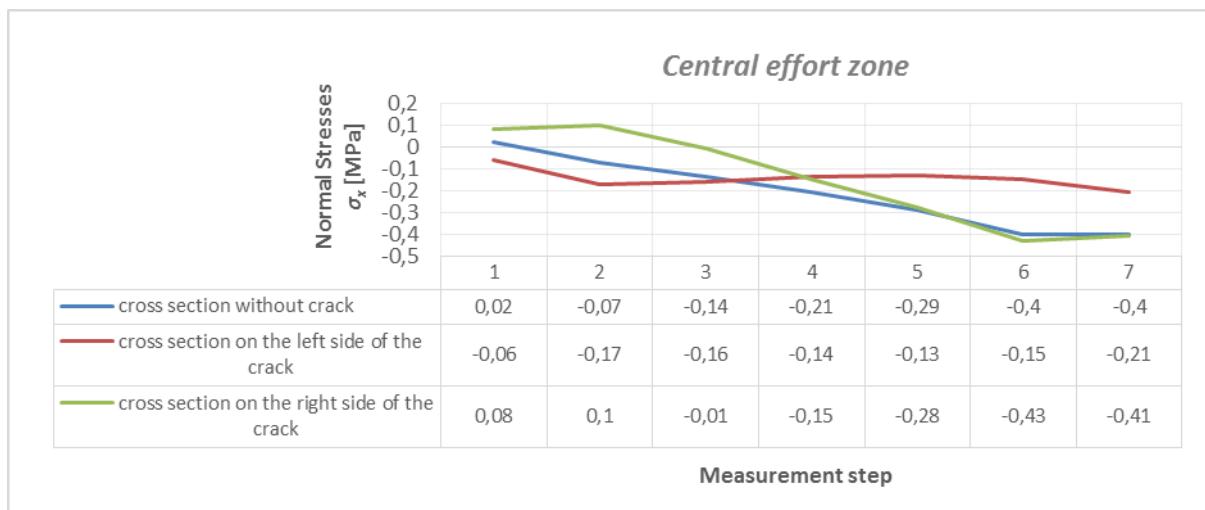
**Fig. 6.** Imperfection focus - effort zone. Diagram of normal stresses in the direction of the local x axis for the cross section of a reinforced concrete panel wall, for models MES1 and 2 (Bieranowski P. 2019)

Fig. 6 compares the results of normal stresses, which were recorded on the left and right edges of the scratch, in relation to the comparative model MES1, while Fig. 7 shows the percentage comparison of the collected data on the left edge, and so, the largest changes were recorded in point 1, -400%, while min. in point 3, 14%. On the right side, the trend analysis was as follows - Fig. 8, the maximum result was monitored in item 1, i.e. 300 and min. in point 7, 2%. In the redistribution zone - Fig. 9, i.e. 0.3 m from the effort zone (on the left), stress values  $\sigma_x$ , have already reached much lower values, and so: max percentage change was noted in point 1, 100% and min. in item 3, 7% - fig. 10. On the right side, the following data was obtained - figure 11 - max 267% in item 1 and min. in point 5, -3%. The summary for the compensation zone (borderline) is depicted in the graph presented in Fig. 12. Fig. 13 compares the results for the left side of the imperfections. On this side the biggest changes - point 5, -15%, and min. 0% in points 1.2 and 3. On the right, Fig. 14, it is noted: max in point 3 with a value of 38% and zero in point 2. Behind these bands, redistribution, compensation takes place in the neutralization zone - further 0.3 m from the last computationally considered band - complete neutralization of imperfection influences in the rigid-spatial arrangement of the structure of a large-panel building.

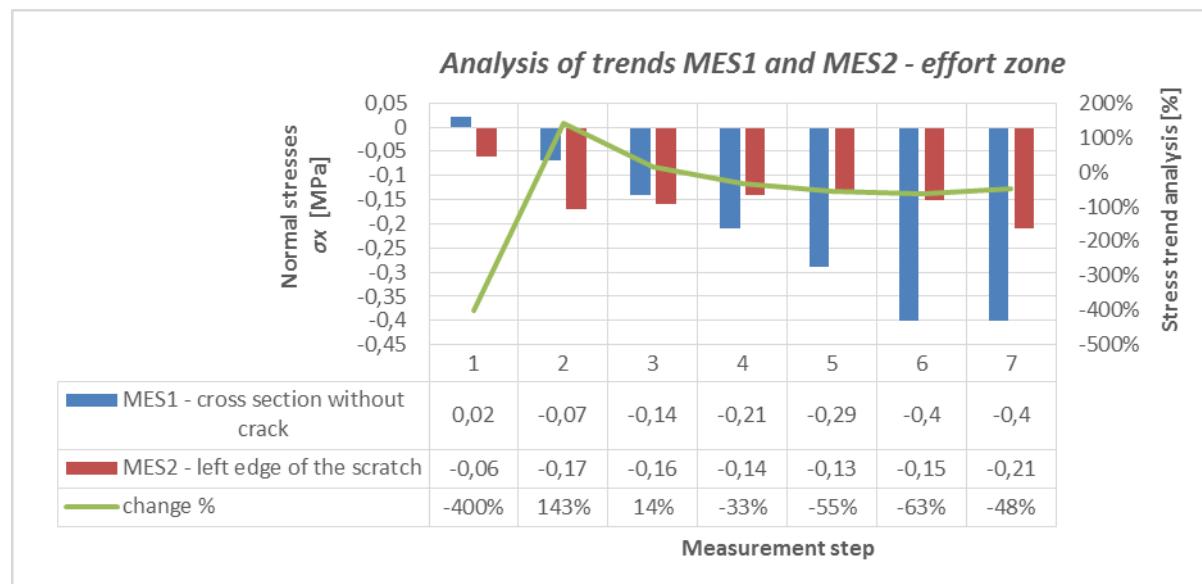
**Fig. 7.** Trend analysis for MES1 and 2 models - consider combining with **Fig. 6**.

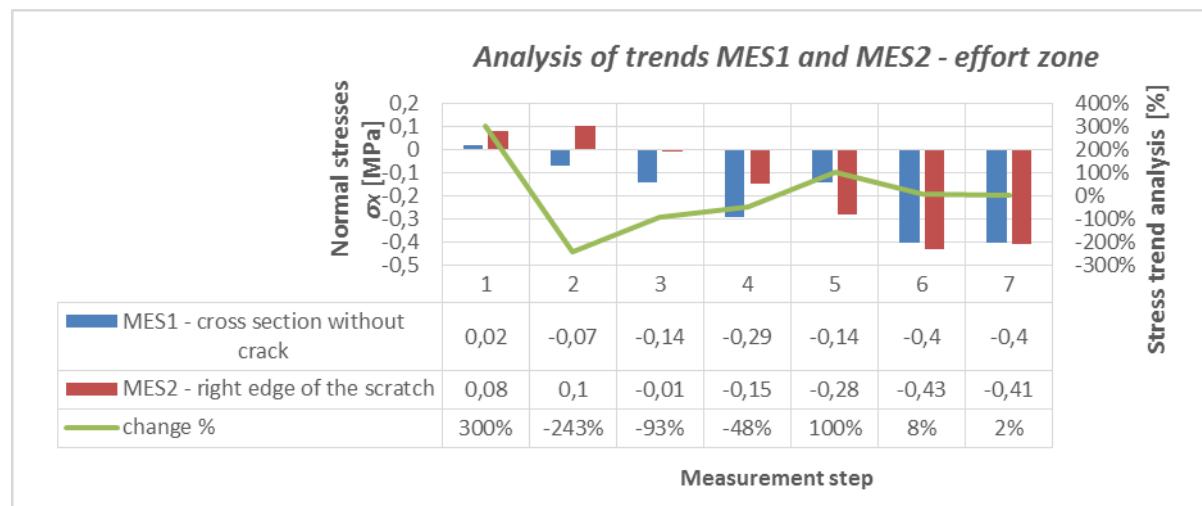
**Fig. 8.** Trend analysis for MES1 and 2 models - consider joining with **Fig. 6** (Bieranowski P. 2019)

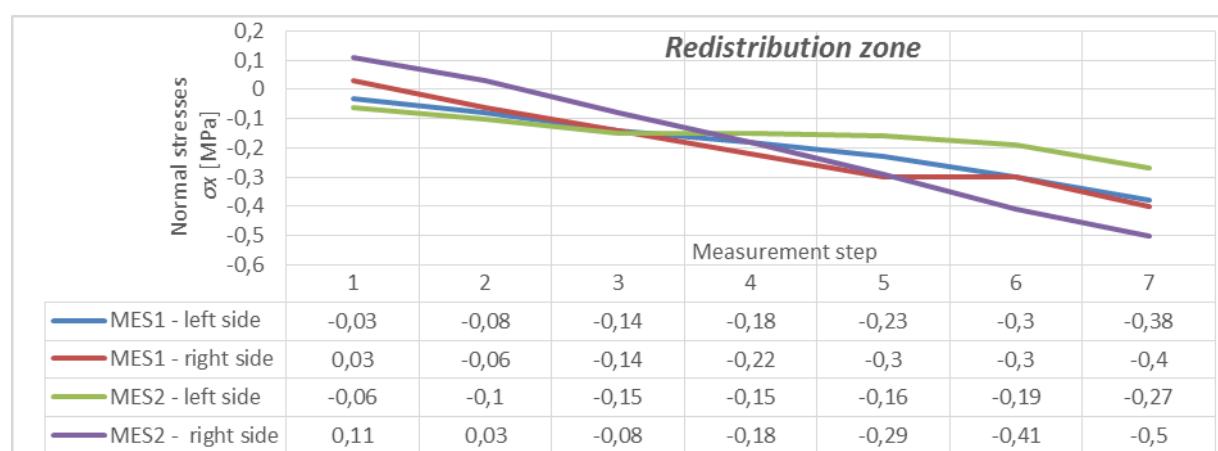
**Fig. 9.** Border zone - redistribution zone (30 cm from central effort zone). Diagram of normal stresses in the direction of the local  $x$  axis for the cross section of a reinforced concrete panel wall, for models MES1 and 2 (Bieranowski P. 2019)

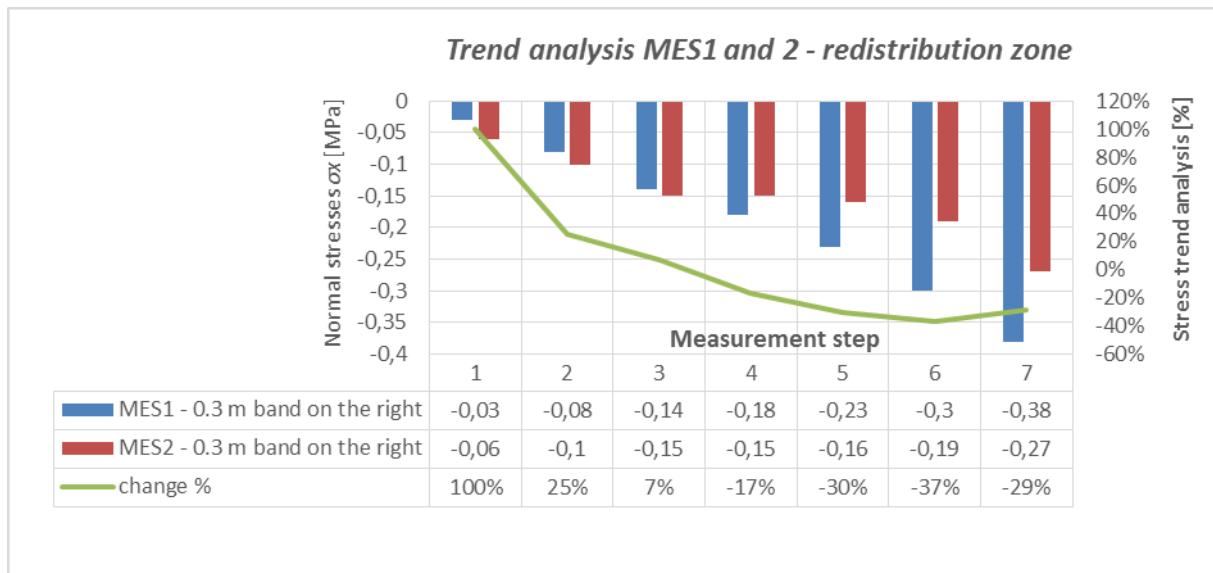
**Fig. 10.** Trend analysis for MES1 and 2 models - consider combining with **Fig. 9** (Bieranowski P. 2019)

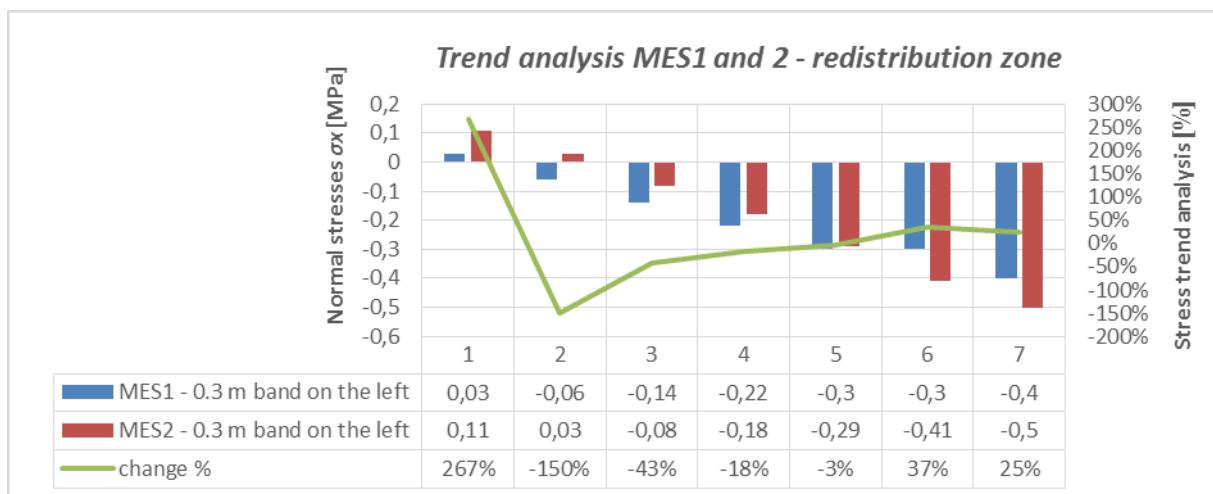
**Rys. 11.** Trend analysis for MES1 and 2 models - consider combining with **Fig. 9** (Bieranowski P. 2019)

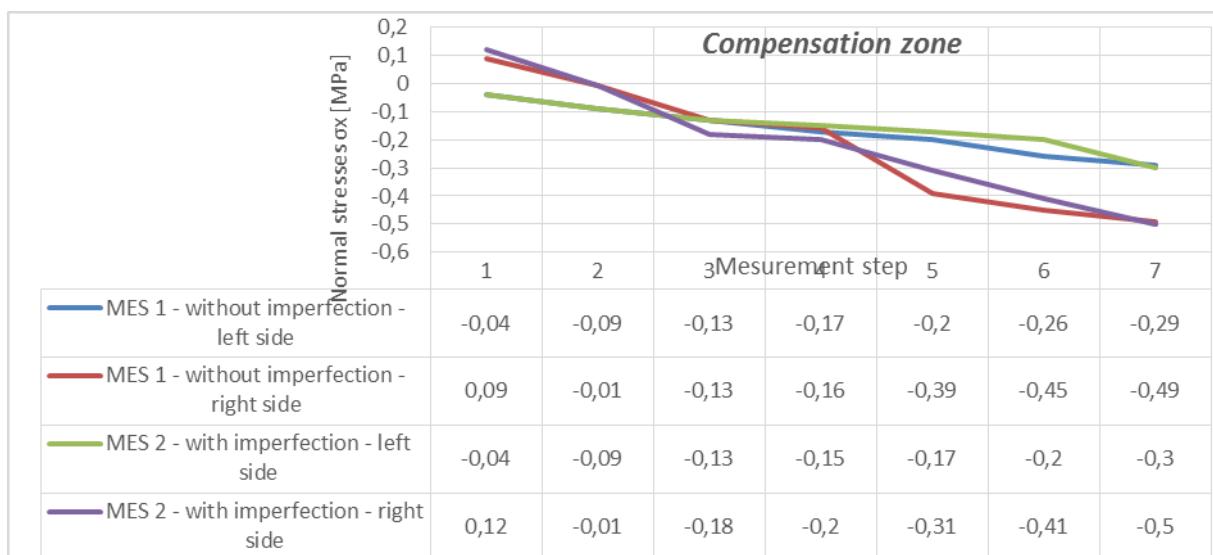
**Fig. 12.** Border area - compensation zone (60 cm from central effort zone). Diagram of normal stresses in the direction of the local  $x$  axis for the cross section of a reinforced concrete panel wall, for models MES1 and 2 (Bieranowski P. 2019)

In conclusion, it should be noted that already at a distance of 0.6 m from the epicenter of the focal point of effort, for several cases the stress equalized in the comparative aspect of both models, moreover, in the band placed at a distance of 0.9 m, the phenomenon of full neutralization with influence is monitored imperfection – the zone of neutralization.

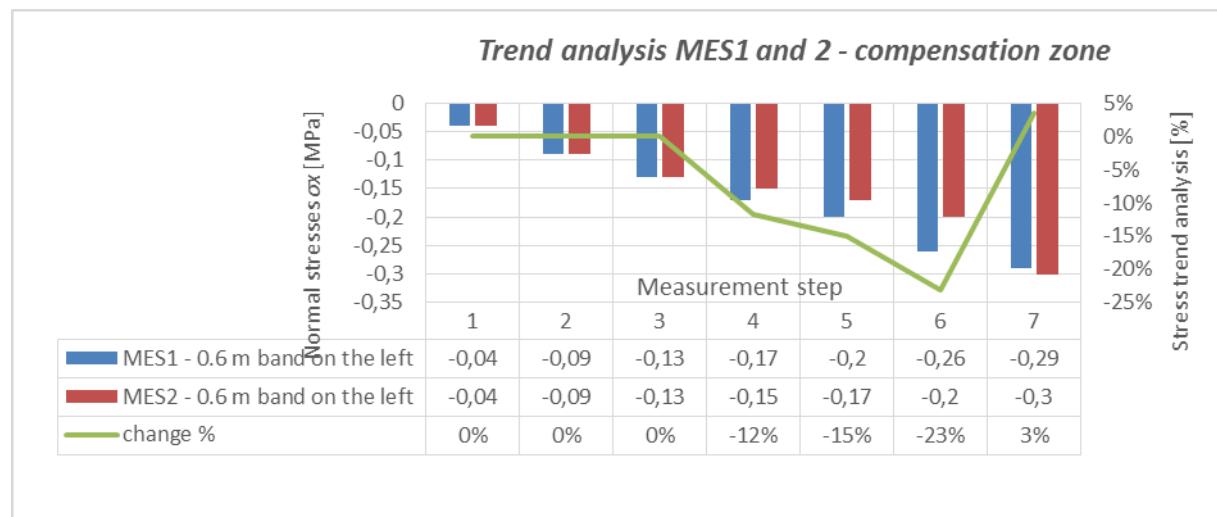
**Fig. 13.** Trend analysis for MES1 and 2 models - consider combining with **Fig. 12** (Bieranowski P. 2019)

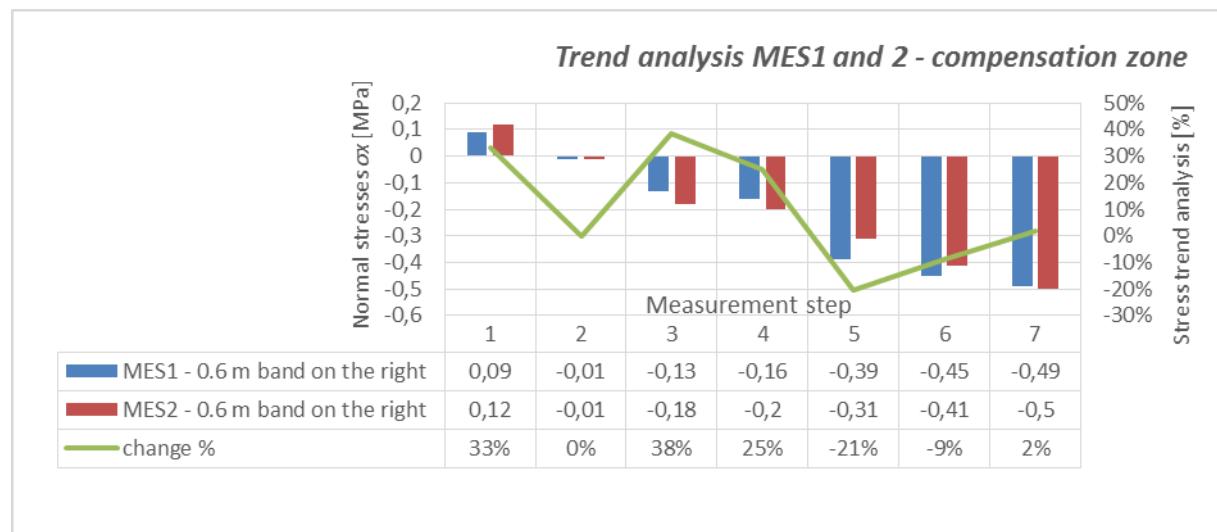
**Fig. 14.** Trend analysis for MES1 and 2 models - consider combining with **Fig. 12** (Bieranowski P. 2019)
