Building modernization located in the conservation protection zone in the aspect of technical conditions

Maciej NIEDOSTATKIEWICZ^{*1}

Abstract

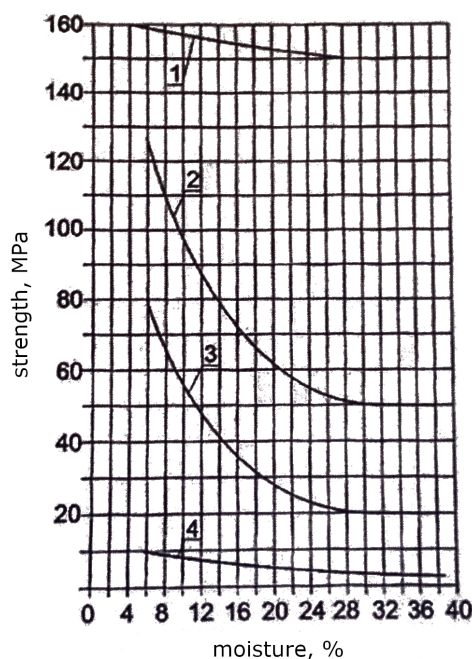
Figure 14. Moisture-strength (stress) relationship for wood [16]

Based on the estimated results of measurements with a hygrometer, it was determined that the degree of moisture in wooden rafters in the eaves zone, defined as the measured mass moisture U_m [%], ranged from 19,26% to 23,32%, which qualified the rafters as damp and from 34,26% to 36,32%, which qualified them as wet (Tab. 2 and Tab. 4). In the case of the formwork of the roof slope, the degree of moisture in the eaves zone, defined as the measured mass humidity U_m [%], ranged from 24,22% to 25,28%, which qualified the boards as damp and ranged from 31.06% to 44,25%, which qualified the boards as wet (Tab. 2 and Tab. 4).

their load-bearing capacity (Fig. 14) [16].
